## **Scott Turner's Report**

## **Truck Accident & Incident Experts, LLC**

**Date:** June 3, 2024

**Case Caption:** John Ross v Knauf Insulation, Inc., et al

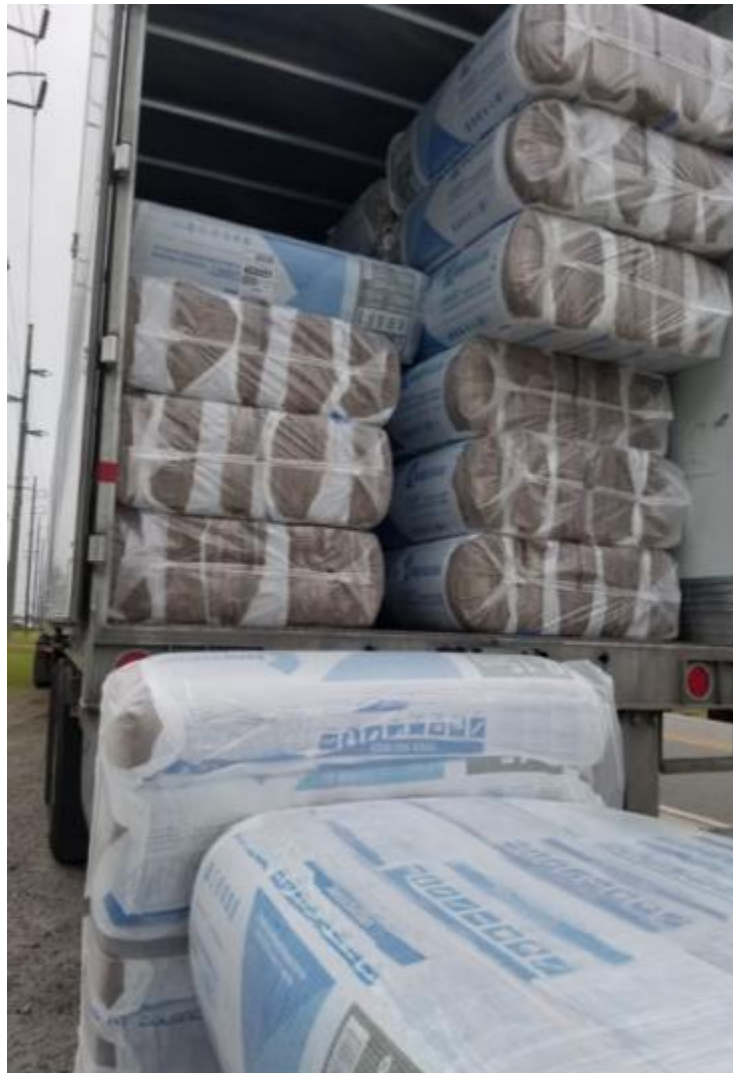
Image #1 and Image #2 below depicts the rear of the Heartland CMV after the articles of cargo (Insulation bats) had fallen onto professional CMV driver Ross:

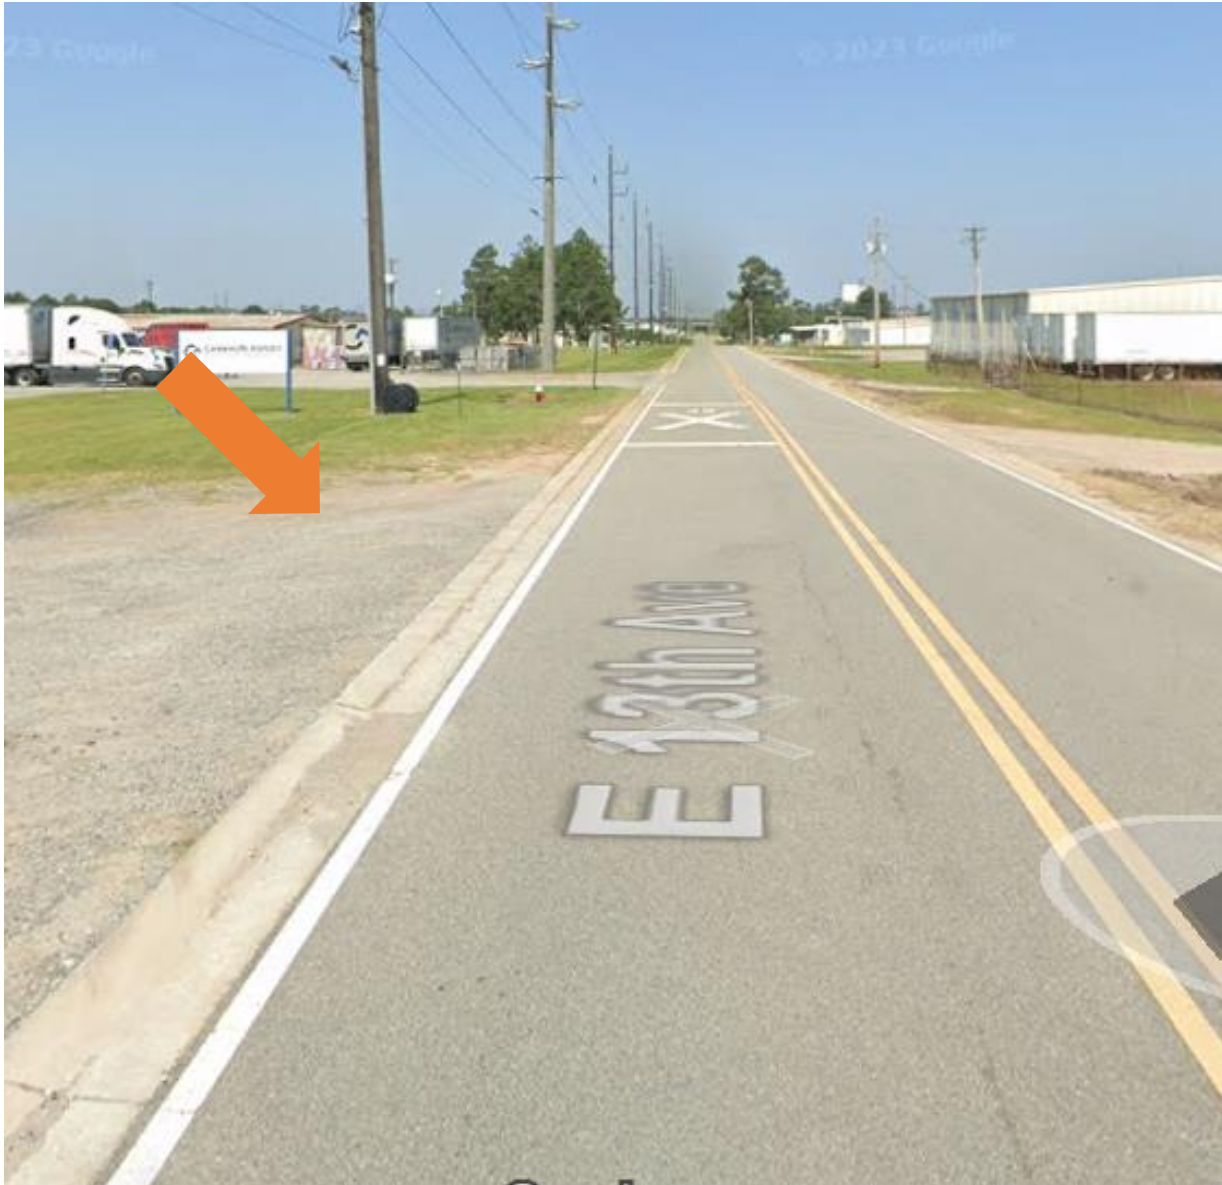
Image #3 below depicts the area of East 13<sup>th</sup> Avenue where the subject incident occurred. The approximate location that the articles of cargo fell from the CMV is marked with an orange arrow:
